UNITED STATES DEPARTMENT OF AGRICULTURE
Bureau of Agricultural Chemistry and Engineering
Naval Stores Research Division

HOW TO STOP LEAKS FROM THE SIDE SAMPLER IN A METAL ROSIN DRUM

By E. L. Patton, Chemical Engineer, Naval Stores Station, Olustee, Florida The metal barrel or drum has come into prominence as a container for rosin. Since drums for rosin are usually equipped with the side sampler, there is difficulty in preventing molten rosin from leaking through the hole or from under the flange of the sample mold holder.

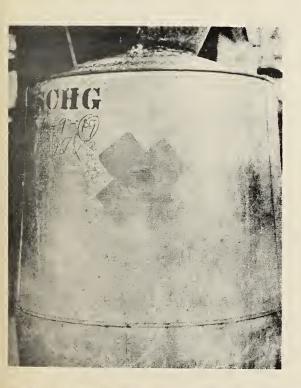
View of side sampler properly covered with two pieces of 3" x 6" gummed paper tape.

The Naval Stores Station has tested a method which successfully prevents leaking of molten rosin at the sample mold holder. This method consists of filling the indentation of the sample mold holder with wet clay, flush with the surface of the barrel, and pasting gummed paper or cloth tape, that will adhere to a new galvanized surface, over the clayed surface and on to the side of the barrel. The tape should be about three inches wide by six inches long. In some instances it is necessary to apply two pieces of gummed tape, forming a cross, over the hole. Powdered asbestos made into a dough with water can be used in place of clay.

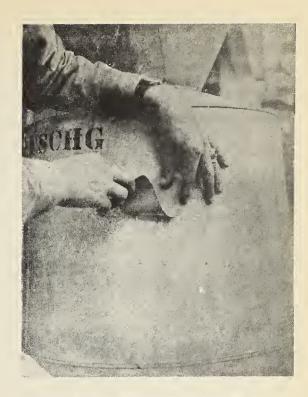
View of the "clayed" sample mold holder being covered with a piece of gummed paper tape.

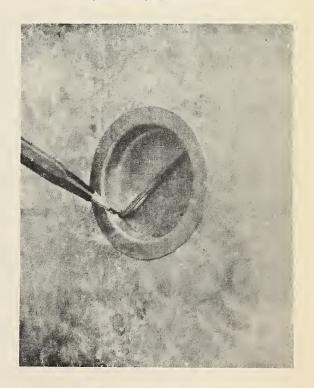
View of a side sampler inserted through a hole in the side of the metal rosin barrel. The pencil points to the hole in the sample mold holder. Leaks often occur from under the flange.
